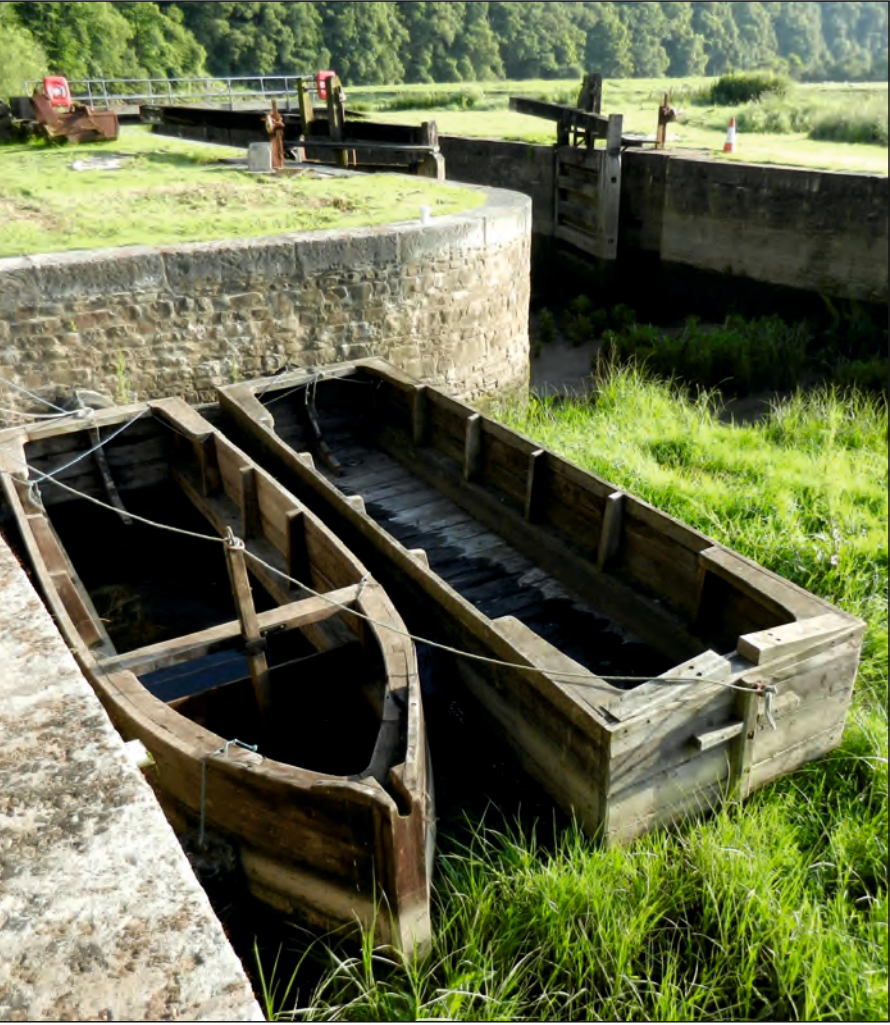
These full-scaled replicas of the lead or bow tub boat and its mate, the butt tub boat, are as used on the Bude Canal. These boats were built by Adrian Wills (Weare Gifford) and Barry Hughes (Appledore), from drawings as part of a survey on the remains of an original Bude Canal tub boat, undertaken by Dr. Blue, a marine archaeologist, on behalf of Bude-Stratton Town Council. Adrian Wills owns the tidal lock and basin on the Rolle Canal. The Rolle Canal was built by James Green, following his construction of the Bude Canal.

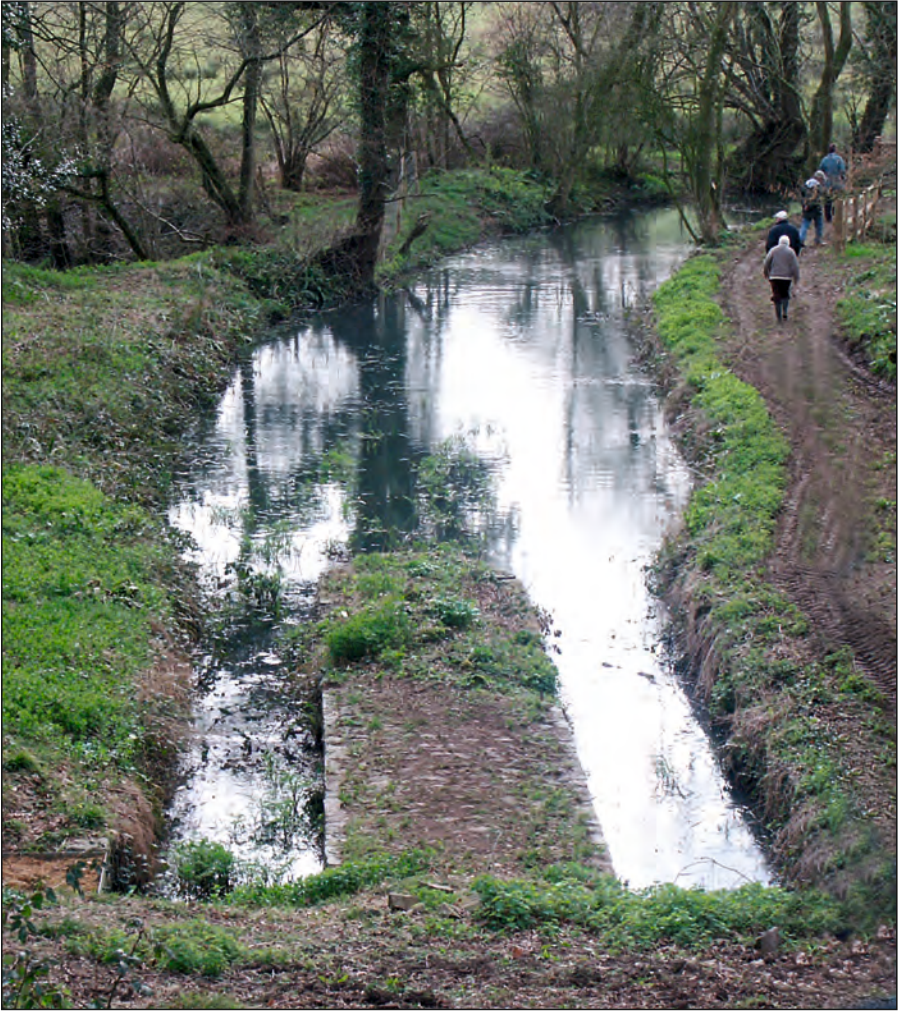
Boat bays at the bottom of Hobbacott Inclined Plane. The left hand bay was for descending boats and the right hand for ascending boats.

At only 4 miles from Bude this was the most important site in the Canal system. Should the machinery be broken or damaged this limited what trade could be conducted. Apart from breakages the incline at Hobbacott was effected by too much water, insufficient water, frozen water or works along the Canal line, as were all the planes.

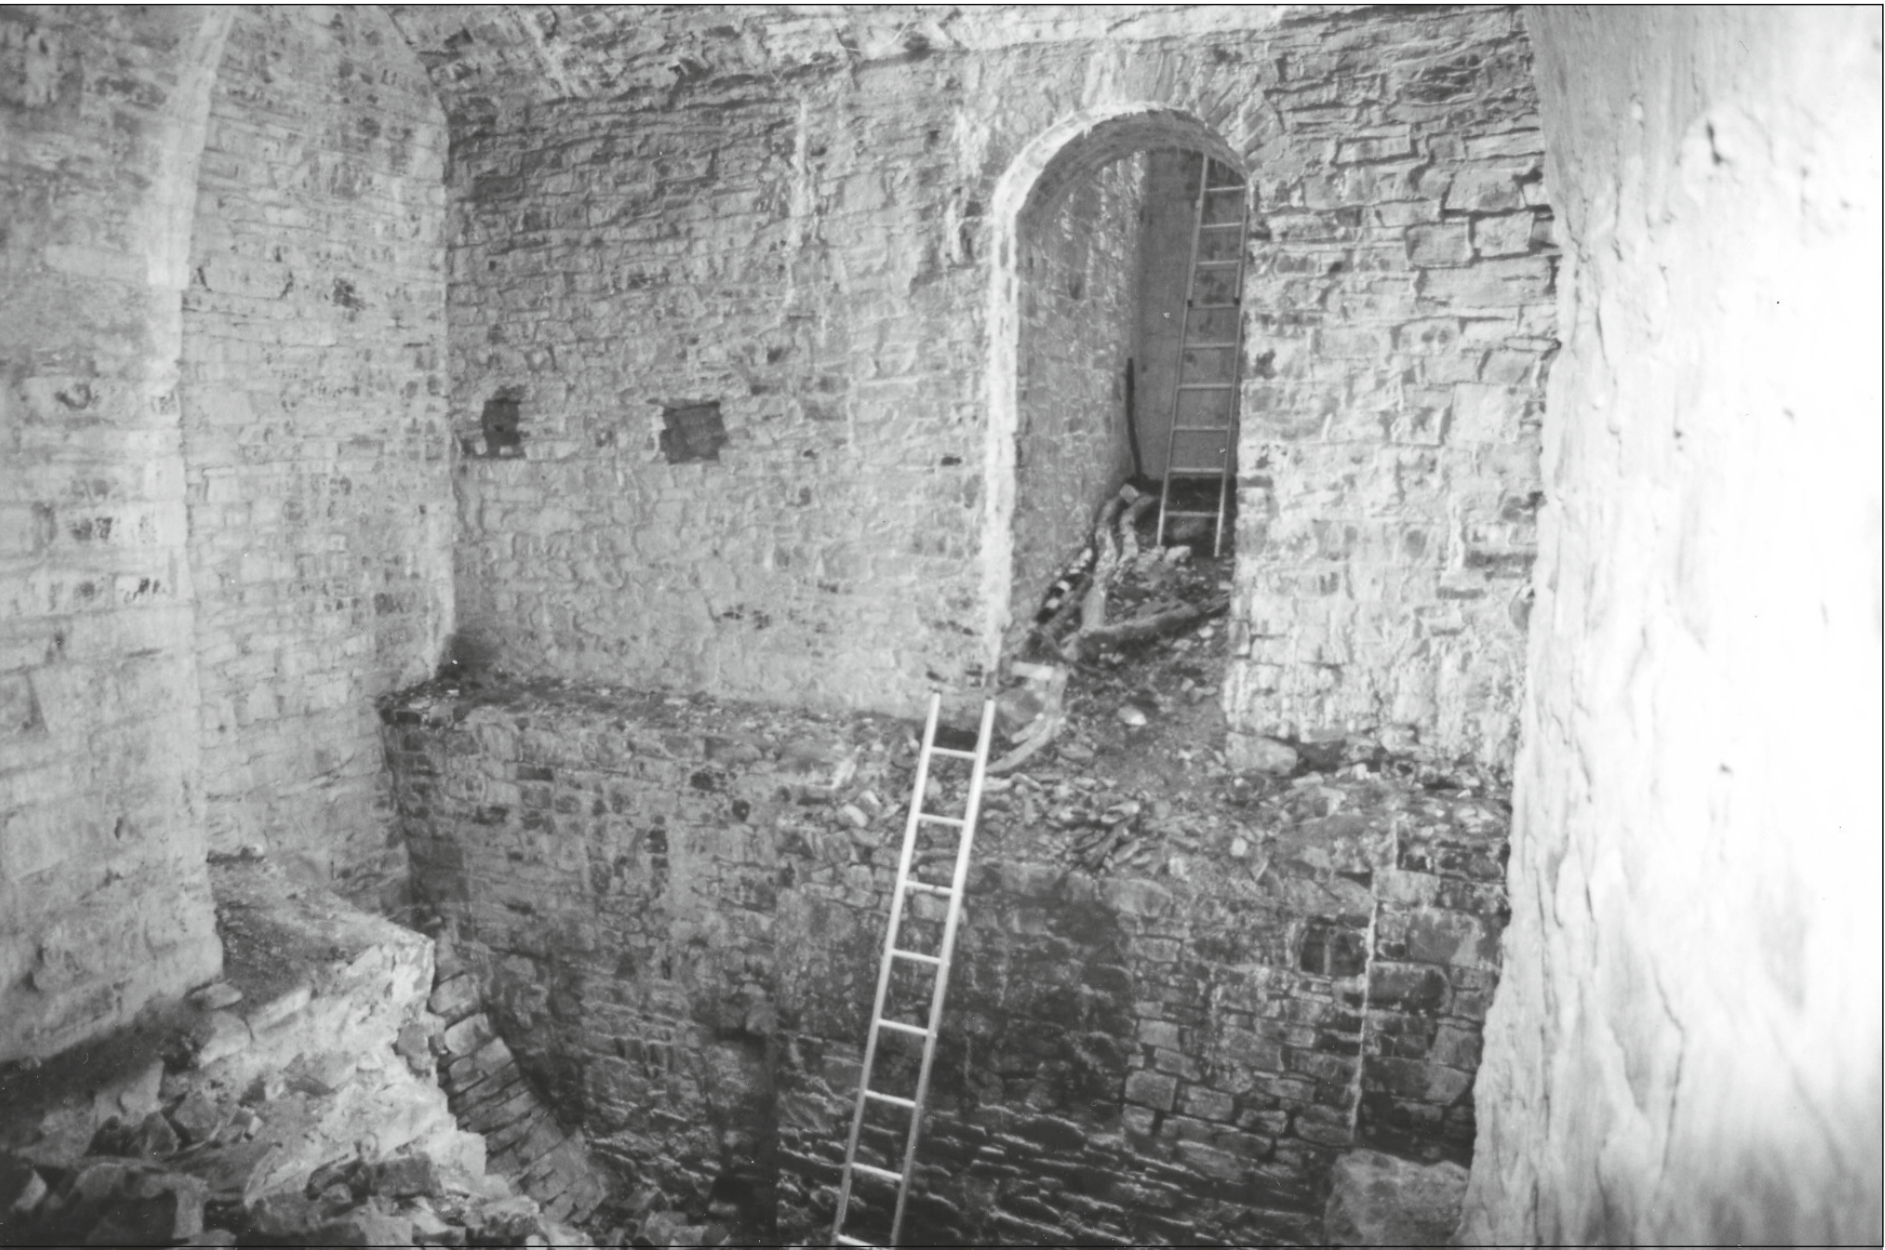
An example of a typical wheelpit as used on the Bude Canal. This chamber housed the massive overshot water wheel ranging from about 20ft diameter up to the largest wheel of nearly 50ft as used at Marhamchurch.

MARHAMCHURCH – The first incline at the end of the Barge Canal, having a plane of 836 feet and a rise of 119’ 8”. It was a water wheel type with a wheel of 49’ 2½” in diameter.
